**Atlantic Coastal Watershed Program Grant:  
Stormwater Basin and Storm Drain Retrofitting Projects in  
support of the Barnegat Bay Watershed  
RP03-036**

## **Project Overview**

# **Stormwater Basin Summaries**

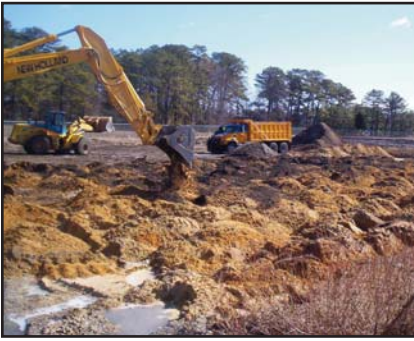
- a. Basin should be excavated an additional 6" below the final basin bottom, avoiding any compaction of the soils. The area should then be evenly covered with a layer of organic material and then covered with "Oceangro" organic fertilizer, gypsum and lime as indicated by the soil tests.

- b. The materials should be mixed in place to a depth of four feet. Then the soil mixture should be aerated by lifting it to a height of 7 to 8 feet and dumping it in place ("Dig and Drop"). The basin bottom should be tilled and dumped in segments, beginning with the areas farthest from the road. After each segment is completed, neither equipment nor machinery should be allowed on the prepared bottom to prevent re-compacting the soil. The prepared bottom will be left with a hummocky rather than smooth condition.

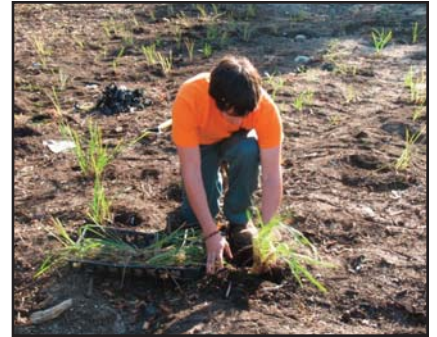
- a. Plants for the bottom of the basin should be a combination of native facultative wetlands tree seedlings and naturalization grasses. All bottom planting should be done by hand so as not to unnecessarily compact the basin bottom.

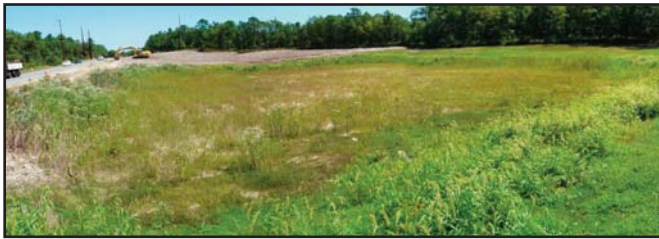
Lighthouse Drive South (2008)

There are two basins at this location. The construction on these two basins was completed in March 2006. An abundance of clay was found in the bottom of both of these basins. The clay was excavated and replaced with fill/compost and the basins were lowered to allow for more volume. Recycled glass drainage pits were installed at the inlet pipes and mulched. These basins are successfully no longer holding water.

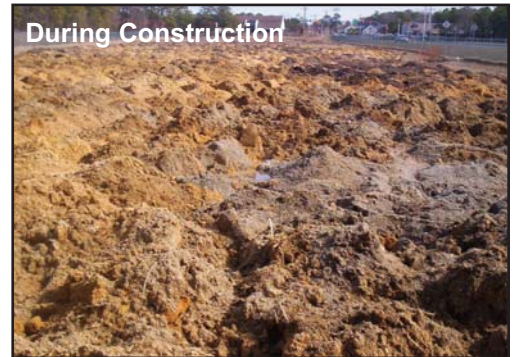
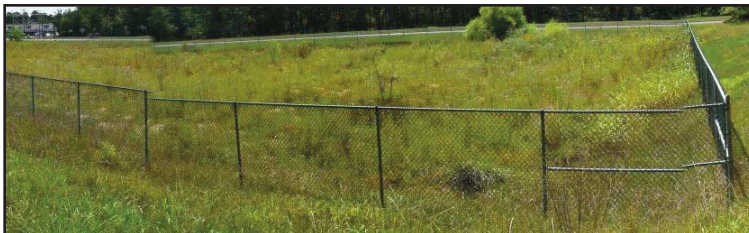
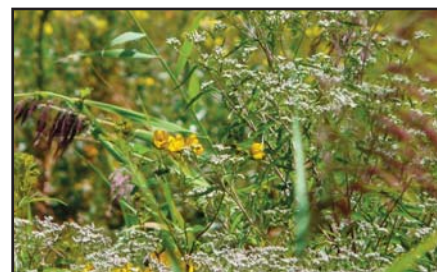
Barnegat Boulevard (2006)

The construction on this basin was completed in March 2006. The bottom of the basin was excavated and lowered to allow for more volume. The soil was replaced with mulch and mixed using the dig/drop method. Recycled glass drainage pits were installed at the inlet pipes and mulched. This basin is successfully no longer holding water and has revegetated into a meadow.

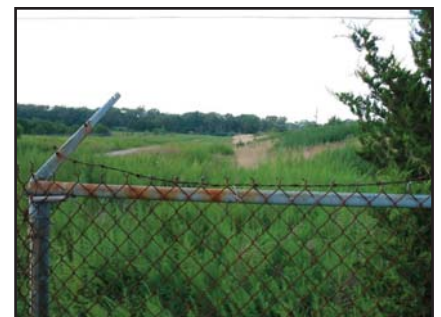
Mizzen Ave. (2008)

Trees and vegetation at the mouth of the inlet pipes were causing water to back up the drainage system, subsequently flooding streets in Beachwood. This basin had also been holding water for several years. Trees and a thick mat of vegetation in the bottom of the basin were removed. Sumps were dug in front of each of the inlet pipes and filled with recycled glass. Soil was removed from the basin and replaced with compost using the dig/drop method. The bottom of the basin was found to be composed of clay and rather than remove it, we dug through it in an attempt to break up the compaction of the clay. This basin is prone to flooding due to groundwater but is dry at this time.

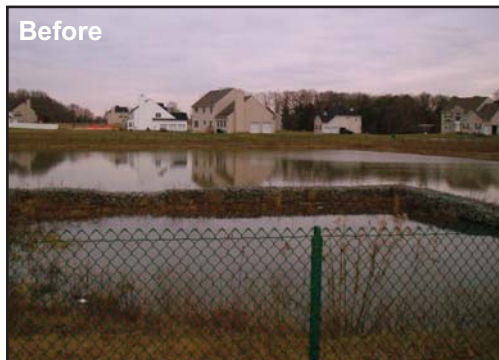
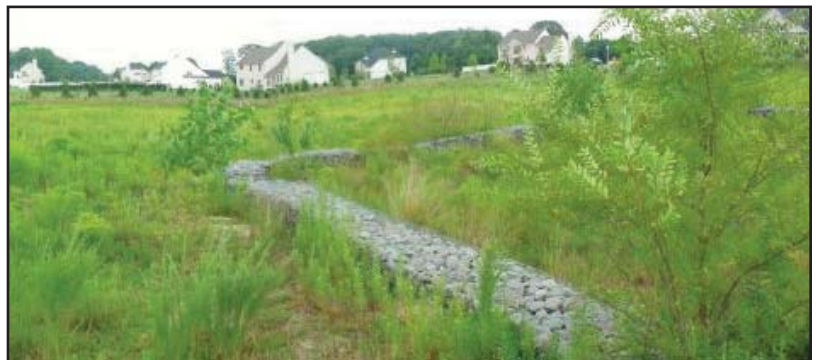
Clearstream Court/ Ridgeway Road (2006)

This 2002 basin was expanded by the developer. After grading and soil loosening procedures had been completed, the basin was still holding water and was not allowing infiltration due to a seasonally high water table. The County held the developer's performance bond contingent upon the basin construction and planting being completed. The County will be responsible for maintaining the basin after the bond is released. County Engineering Department worked with the developer on developing a solution to improve infiltration and plant recommendations. Gabion walls were constructed, and in June 2007 the basin was planted with gamma grass and other native grasses at the toe of its slope and on the bottom to improve soil structure and infiltration.

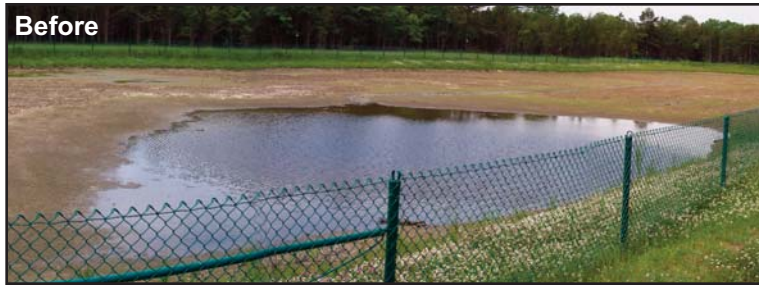
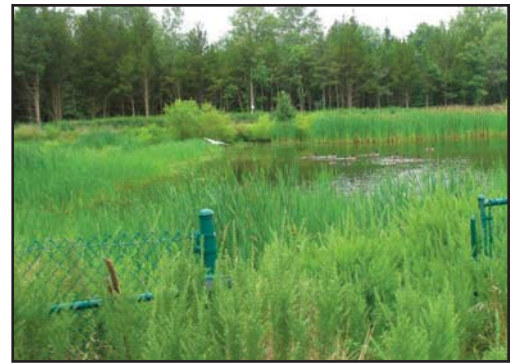
Ridgeway Road East Basin (Cty. Rte. 571) (2004)

Since the basin's construction in 2002, it has consistently had a problem with holding a large volume of water, although the water table is several feet below the the surface. Throughout the grant period, unsuccessful attempts were made to dewater the basin in order to grade the basin and construct the glass infiltration pits.

Although the basin continues to hold water, wetlands vegetation

has become established and it has become a wetlands habitat for a number of species, including a white egret sighted during a recent site visit.

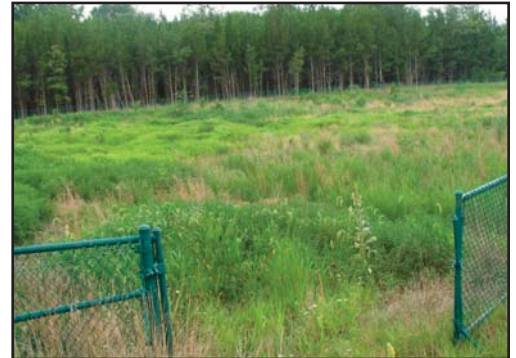
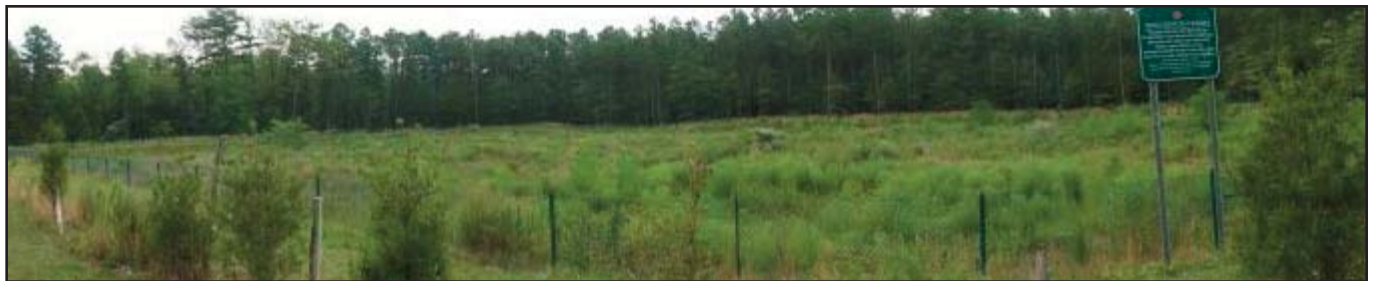
Ridgeway Road Middle Basin (Cty. Rte. 571) (2008)

Compost was incorporated and mixed in using the dig/drop method. Pits of recycled glass were also installed at these locations. The construction of these basins was completed Fall 2004 and was stabilized with plantings of native woody seedlings in Spring 2006.

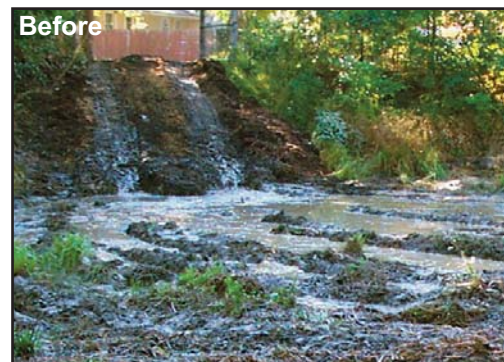
11th Ave. / Bismark / Commonwealth (2002)

This basin was constructed around 1970. Due to compacted soils, the basin did not function properly and held water even during drought conditions. There was little if any recharge to groundwater. It was a breeding ground for mosquitoes which plagued area residents for years. Pesticides had to be applied twice a month by the Mosquito Commission to control the problem.

Construction began Fall 2002 and completed May 2003. An excavator was used to dig down approximately 10 feet to penetrate the compacted soil layer. Chunks of compacted soil resembling rocks were unearthed during the process. The excavator worked from the back of the basin to the front to ensure that its weight did not re-compact the basin.

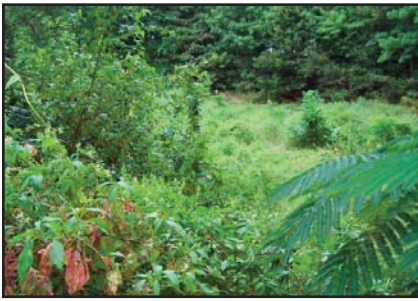
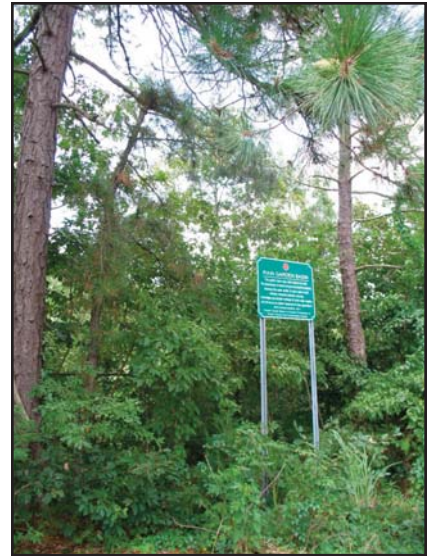
11th Ave. / Bismark / Commonwealth (2005)

Approximately 260 tons of leaf compost from the County's Northern Recycling Center in Lakewood were mixed into the soil to provide organic matter and to encourage the return of biological activity to the soil. The material was applied approximately 12" thick across the basin. Limestone was mixed in to the soil at a rate of 2 tons per acre to attain a pH range of between 5.5 and 6.0.

The basin was seeded with native grasses, ie Tall Fescue, Annual Rye and Grain Rye and woody plantings Red Maple, Pitch Pine, Sweet Gum saplings were installed in the basin Spring 2003. This basin has been successfully restored as a forested natural wooded depression.

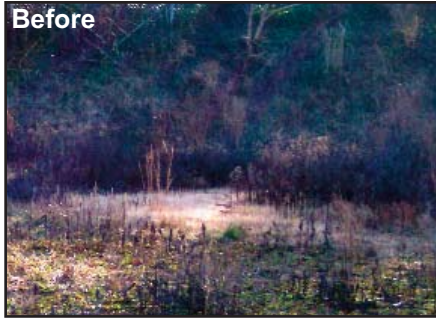
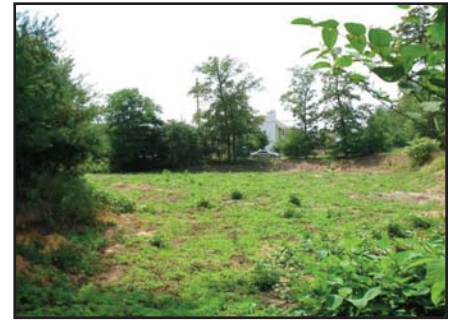
Sunset Ave. (2004)

This basin is located across Sunset Avenue from the Rutgers Cooperative Extension Office in Toms River Township. The basin was originally constructed in 1995/6. Work on the basin began in December 2004 and was completed in April 2005. Work included grading and final

stabilization plantings of native woody seedlings. This basin was recently disturbed with unauthorized maintenance and needs to be remediated.

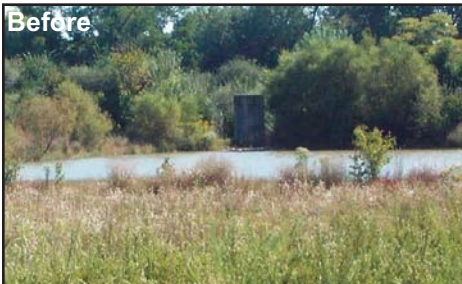
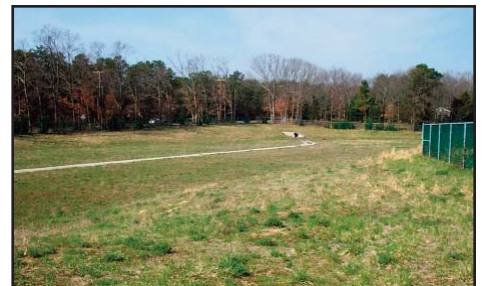
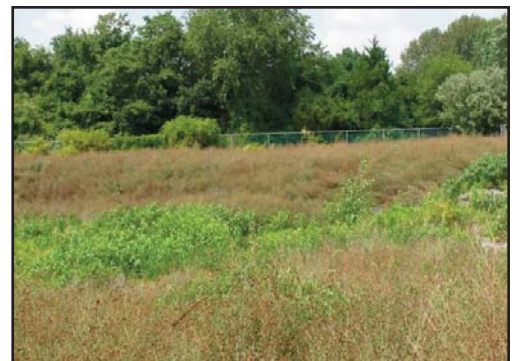
Silverton and Old Freehold Rds. (2000)

In 2000, this basin held water and was reengineered in 2003. Al-

though it then did not hold water, most of the stormwater was not recharged as it was carried away by the low flow channels. In addition, the County Engineering Department was concerned about a future increase in flow to the basin from a proposed large residential development.

Subsoil tests revealed compacted layers 5 inches and up to 10 feet below the surface. In Spring 2004, work was begun. The soil was loosened to a depth of 5-6 feet and deeper where necessary. Compost and lime were mixed into the soil and the low-flow channel permanently removed.

After the excavation work was completed, the basin was found to continue to flood the roadway during significant rain events. To correct the flooding and infiltration issues, the bottom of this basin was excavated and lowered roughly 3-4 feet to allow for more water capacity. Recycled glass drainage pits were installed. Composted materials and gypsum were incorporated into the soil through the dig and drop method. A gabion wall was installed to stabilize the steep slopes. The basin was seeded with a warm season grass mixture and native woody seedlings were planted in Spring 2005.

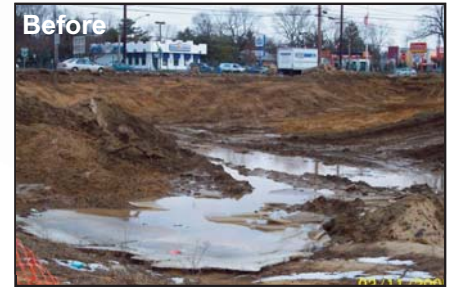
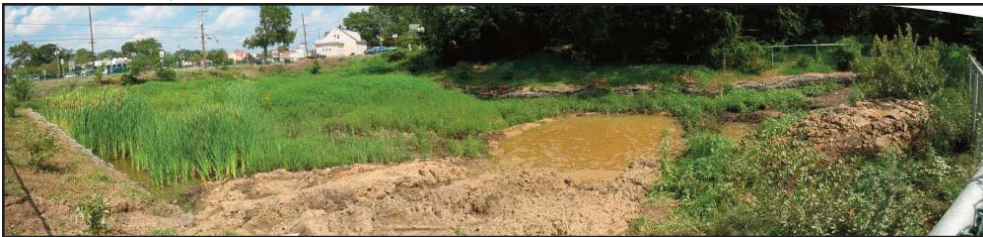
Garden Ave. and State Hwy. 37. (2005)

In 2005, this basin was expanded by the Road Dept, including reconstruction of the slopes and the construction of gabion walls. Compost was mixed in during construction of the basin using the dig/drop method. Pits filled with recycled glass were installed in the center of the basin and in front of the outlet weir. It was stabilized with plantings in Fall 2005; however after a heavy rain, the basin was once again holding water. To address this, the weir on the outfall side of the basin was inverted to allow for positive drainage.

In August 2007, an AquaSwirl™<sup>1</sup> unit was installed at the Garden Street basin to address the serious sediment and debris problem, due to littering from Route 37. Although the debris problem seems to be mitigated, the basin is still holding water near the outlet and the project partners will continue to attempt to resolve this problem.

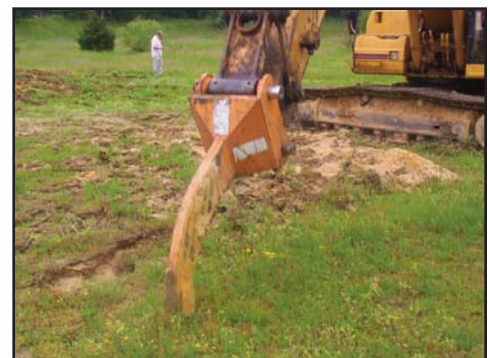
Ripper Demonstration at Vermont Ave. (2005)

The USDA-NRCS performed an evaluation of the soil conditions, areas of compaction and depth to seasonal high water table and has made recommendations on how to proceed with the restoration work. This basin bottom has compacted topsoil down to 20 inches.

This basin was not restored through this grant. However, it is noteworthy as the soil ripper demonstration took place here. A local contractor demonstrated the effectiveness of using the ripper to loosen the hard compacted basin bottom. Subsequently, the ripper was purchased January 2008.

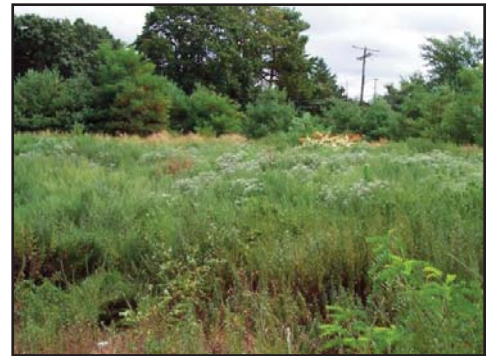
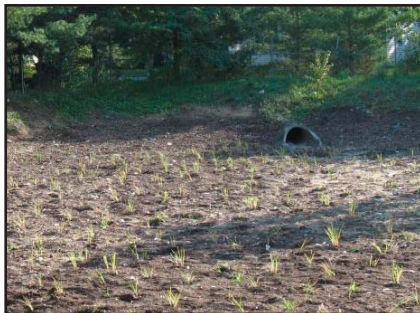
Division and Boyd Streets (2005)

Due to flooding conditions in downtown Toms River, the Ocean County Engineering Department along with the OCSCD investigated the possibility of restoring this basin to reduce flooding on Dayton Avenue. Investigation confirmed that the basin was severely compacted.

The dig and drop method was used to loosen the compacted layer and organic material, gypsum and lime were incorporated to improve soil porosity and recharge capability. Excavation and grading were completed in December 2002. The basin was stabilized with seeding and planted with woody plant material in Spring 2003.

Following the completion of this work, the basin completely drained within 24 hours of a storm event. It was decided to install a biolog to divert the flow from the outlet elongating the flow path and increasing infiltration through the basin bottom and side slopes. Stormwater collected in the basin did not reach the outlet structure and it eliminated flooding problems at Dayton Avenue. The basin completely revegetated.

This basin was recently disturbed with unauthorized maintenance. However, bulk density tests revealed that it was not severely compacted from the maintenance and it was restored with topsoil and seeded with gamma grass in September 2008.

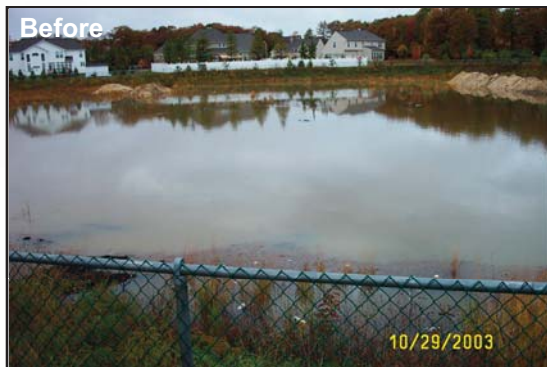
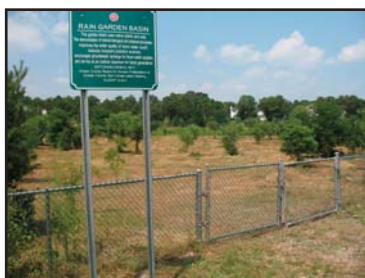
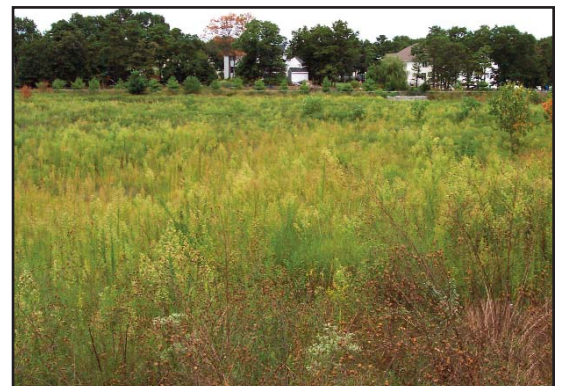
New Hampshire Ave. (2003)

The dig and drop method was used to restore this large basin. Mulch, gypsum, lime and "Ocean Gro" were incorporated into the soil. The OCSCD seeded the basin and assisted in planting numerous woody native tree seedlings in the basin. Larger trees were planted to augment the restoration of the basin.

An obstruction was discovered and removed from the outlet pipe in May 2004. This obstruction was contributing to the drainage problems at the basin. Once excavation began, it was discovered that the compacted layer was only around 4

inches deep, as opposed to multi-

ple feet in the other basins and therefore easily broken up. The basin was completed in June 2004. This basin was recently

disturbed with unauthorized maintenance. However, bulk density tests revealed that it was not severely compacted from the maintenance and will revegetate.

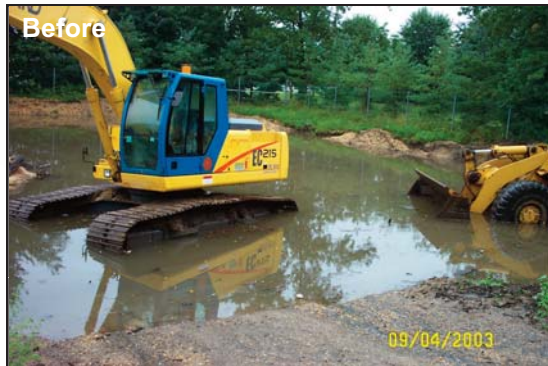
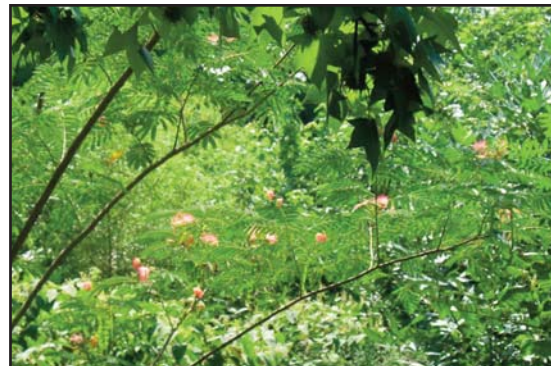
Gilbert / Division Streets (2003)

Preliminary assessment and characterization completed late 2002. Excavation on this basin began in the Fall of 2003. However, a large amount of junk and debris was soon unearthed. Prior to its construction as a County basin, the site had been used as a parking lot with an adjacent residential structure.

Remaining debris was removed from the basin and disposed of at the Ocean County Landfill and a local concrete recycling facility. Lime and compost were brought in and integrated into the soil. The basin was completed in June 2004 and restored to a forested rain garden.

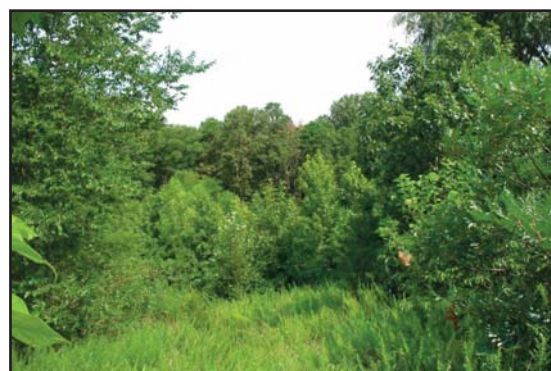
Bay Avenue (2000)

This basin held water for many years. It is a small regional county facility that receives runoff from the adjacent Baptist Church and road runoff from Bay Avenue. Due to severe soil compaction, this basin held over five (5) feet of water for several months of the year. It was drained down by the Ocean County Road Department and several truck loads of composted mulch, gypsum and Ocean Gro were incorporated into the soil through the dig/drop method. While this basin still holds about one (1) foot of water in a small portion of the basin, it is believed that it is functioning much better.

Native grasses, trees and shrubs have been planted and it appears today as a natural wooded depression. A rain garden sign has been installed at this basin, and the adjacent neighbors have expressed their appreciation for reducing potential mosquito habitat. Work was completed in June 2004.
